Project Name: [REDACTED]

Project Definition: The purpose of this visit was to perform BSI and visual inspection on ESN: [REDACTED] Gas Turbine.

Brand: General Electric
Model: 7LM2500-PK-MD
ESN: [REDACTED]
Year of Manufacture: 1999
GT Running Hours: 48,725Hrs.
Package Running Hours: 102,430 Hrs.
Fired Start: 855/44
TSN (Time Since New):
TSLO (Time Since Last Overhaul) No overhaul was performed.
Current Status: Not running, has been cranked once a week.

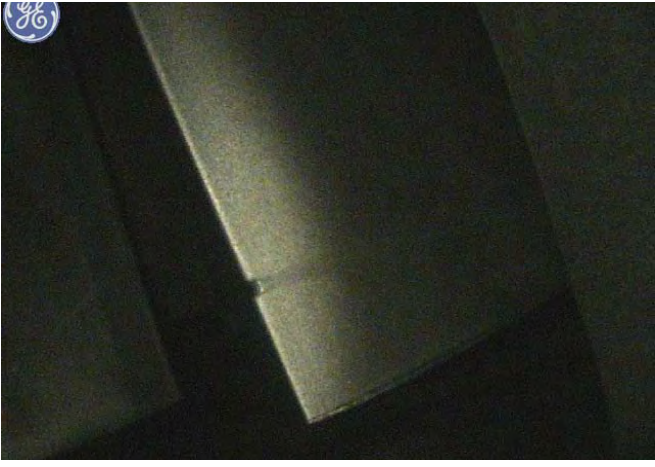
HPC STG5 Nick on L/E side

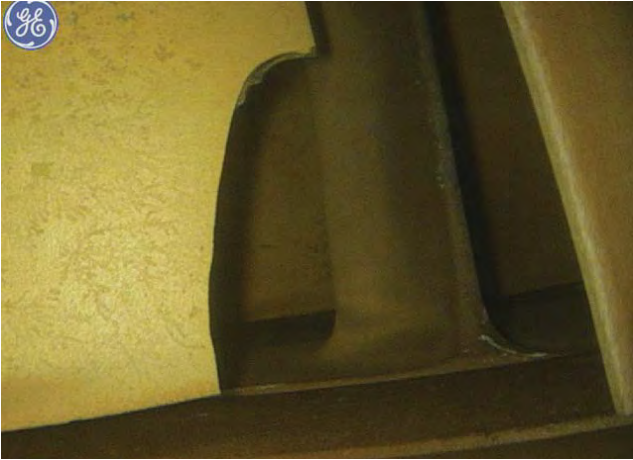
HPC STG12 Blade Missing on T/E side
Serviceable Table:4, 2/b

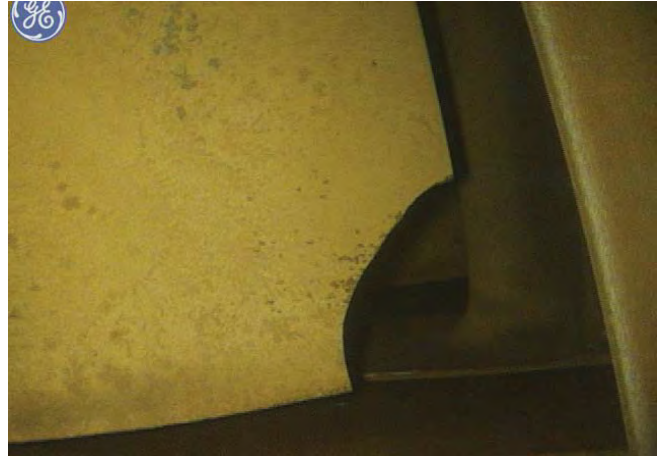
HPC STG12 Blade Missing on T/E side
Serviceable Table:4, 2/b

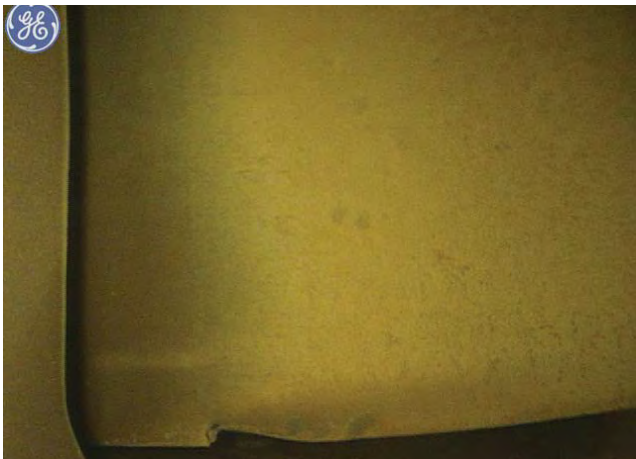
HPC STG12 Blade damage on Tip Cord area

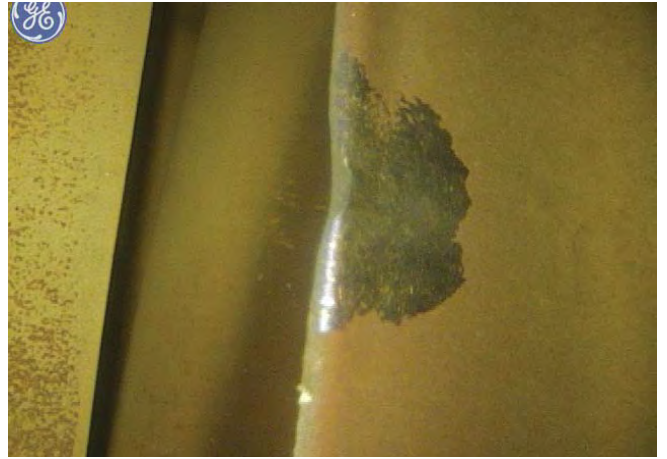
HPC STG12 Blade Dent on L/E wall

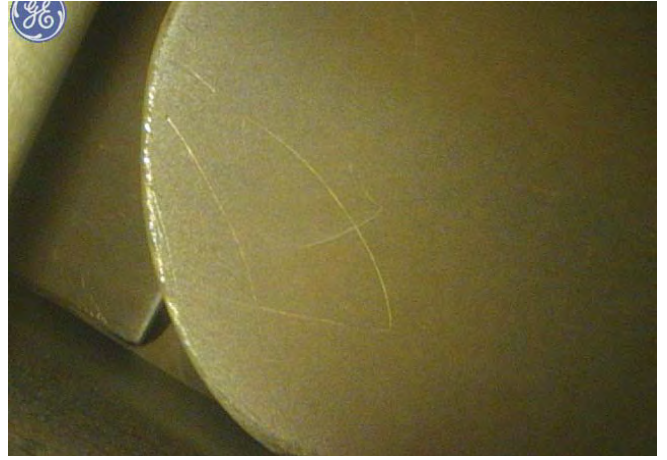
HPC STG13 Blade filed on L/E side

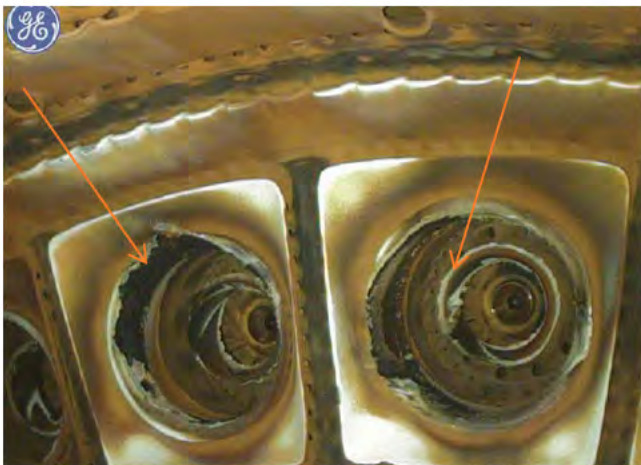
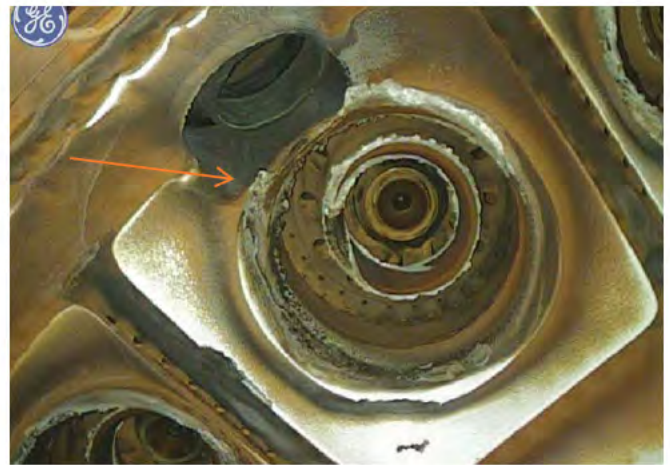
Deposit accumulation and TBC missing on the Venturi (Secondary Swirler), Swirler Cup & Trumpet area.

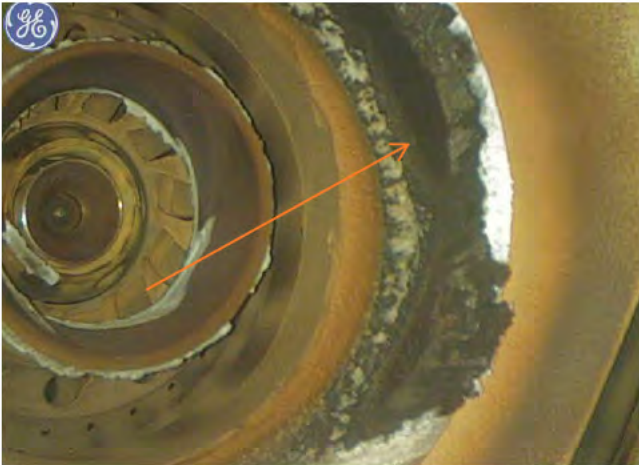
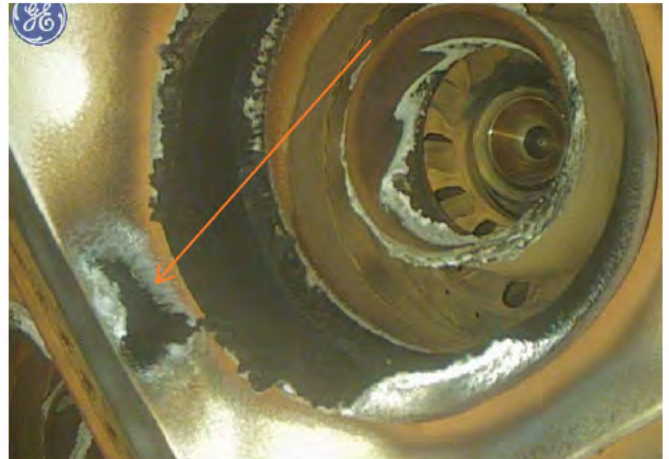
TBC missing and erosion on Trumpet/Splash Plates

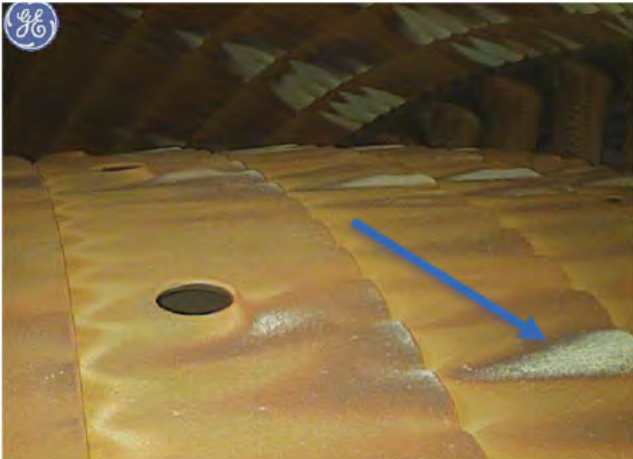
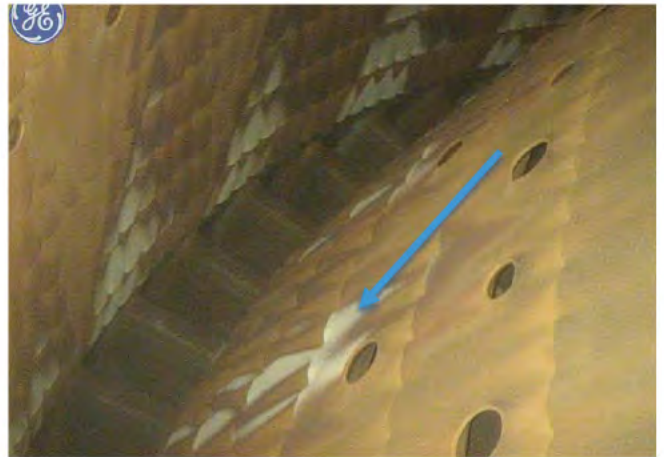
Combustor Inner Liner Condition observed some discoloration areas on the scoop louvers.

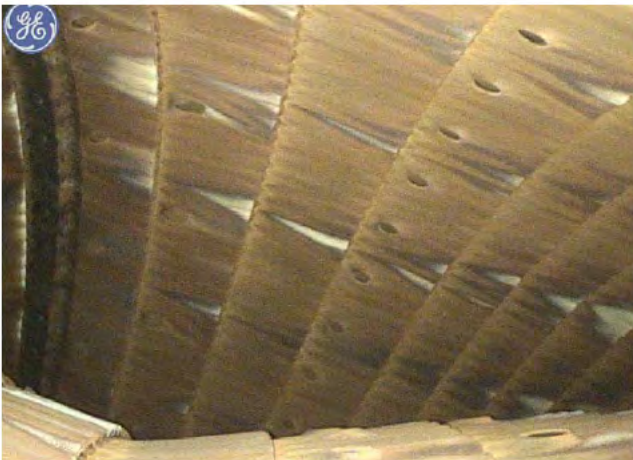
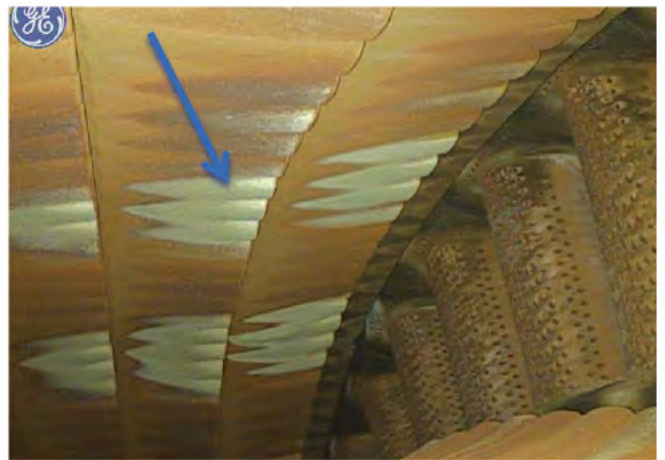
Combustor Outer Liner Condition observed some discoloration areas on the scoop louvers.

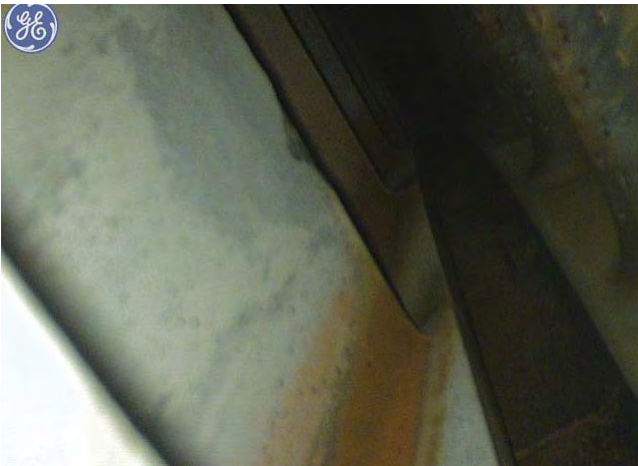
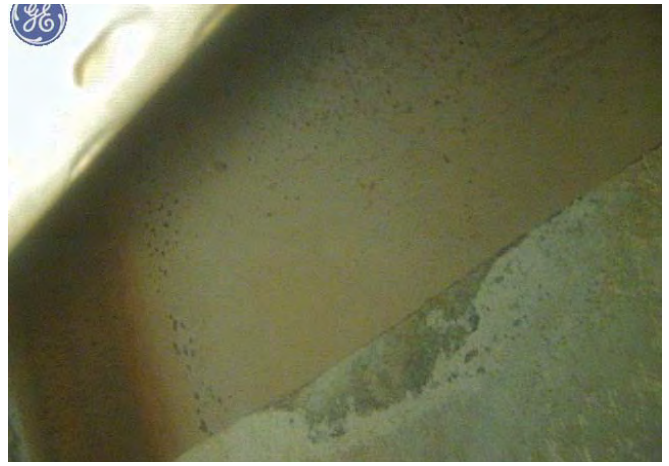
- Observed Eroded areas on the two HPT STG1 Nozzle Vane Trailing edge sides. Serviceable.
Ref: Table:7 /2f

Eroded areas on the HPT STG1 Nozzle Vane Trailing edge side. Serviceable

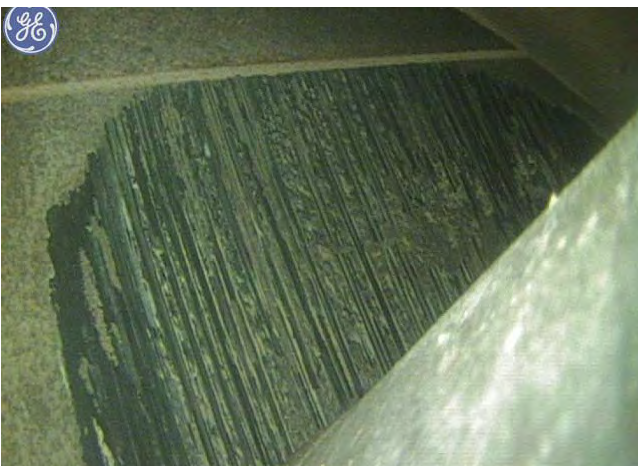
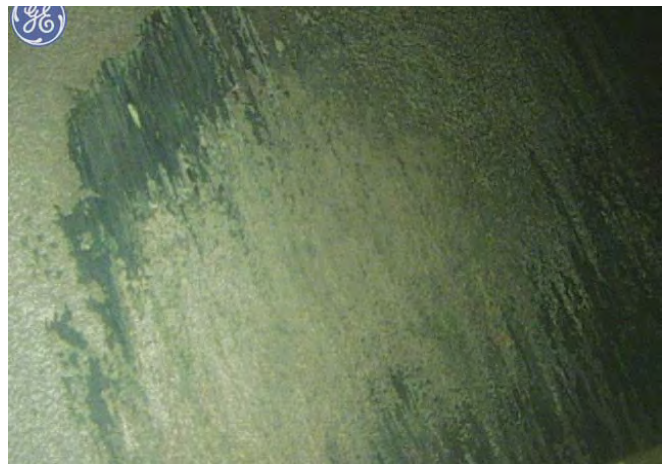
Observed blade rubbing and corrosion on HPT STG1 Shroud. Ref.: Table: 7/ 5a

Blade rubbing and corrosion on HPT STG1 Shroud.

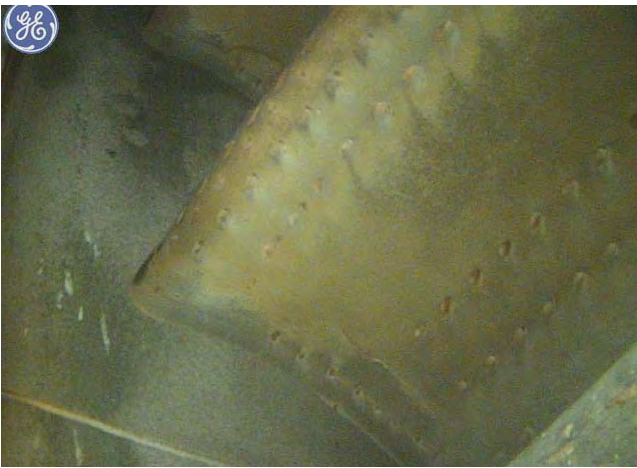
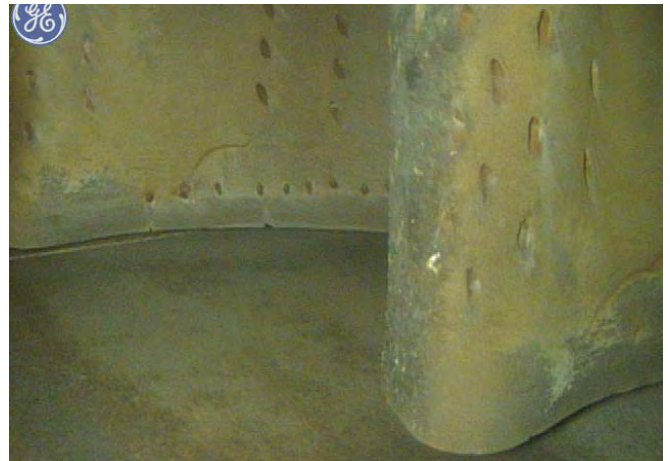
HPT STG1 Rotor Blades are serviceable according to WP406 00, Table 7.

Discoloration on the HPT STG1 Blade LE

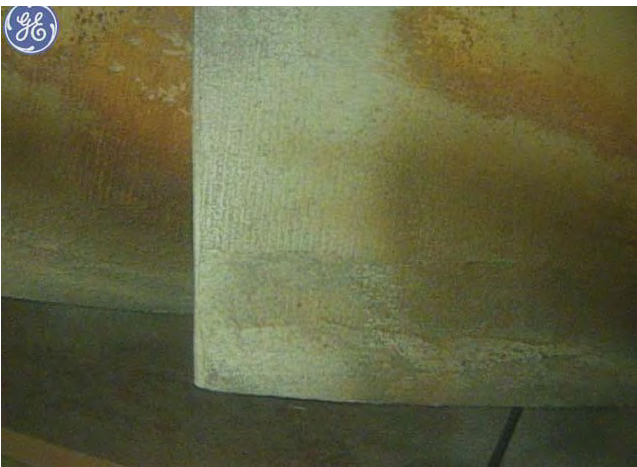
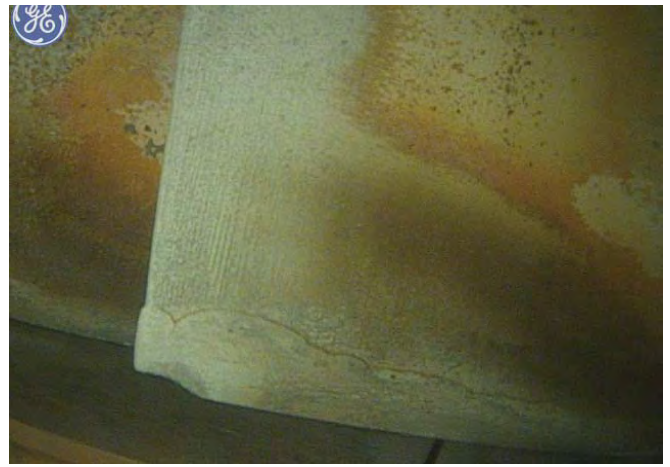
Discoloration on convex surface of STG1 blades and missing on the tip cap trailing edge corner. (only one blade)
