Project Name: [REDACTED]

Project Definition: The purpose of this visit was to perform BSI and visual inspection on ESN: [REDACTED] Gas Turbine.

Brand: General Electric
Model: 7LM2500-PK-MD
ESN: [REDACTED]
Year of Manufacture: 1999
GT Running Hours: 48,725Hrs.
Package Running Hours: 102,430 Hrs.
Fired Start: 855/44
TSN (Time Since New):
TSLO (Time Since Last Overhaul) No overhaul was performed.
Current Status: Not running, has been cranked once a week.

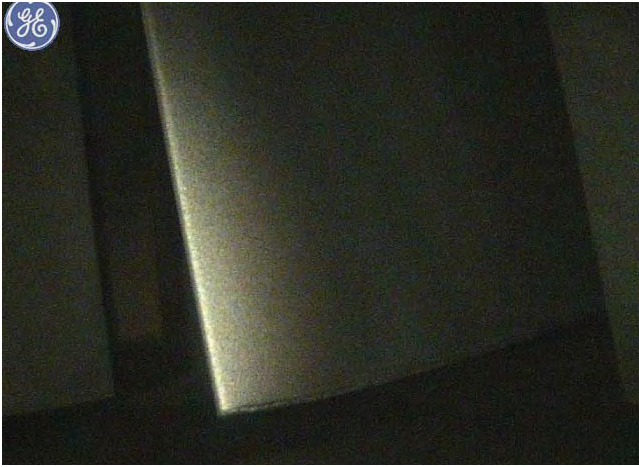
- HPC STG5 Blade, nick on the Leading Edge.
- HPC STG11 Blade, Nick on L/E side.
- HPC STG12 Blade Missing on T/E side (2 blades have missing.) WP 406 00Table:4/ 2b
- HPC STG12 Blade damage on Tip Cord area
- HPC STG12 Blade Dent on L/E wall

HPC STG5 Blade

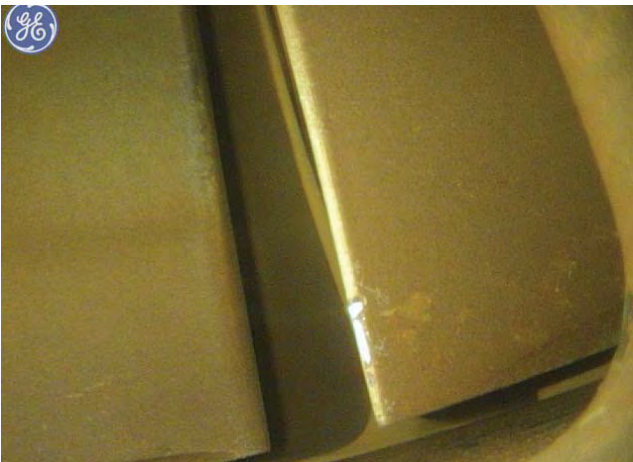
HPC STG11 Blade Nick on L/E Blade

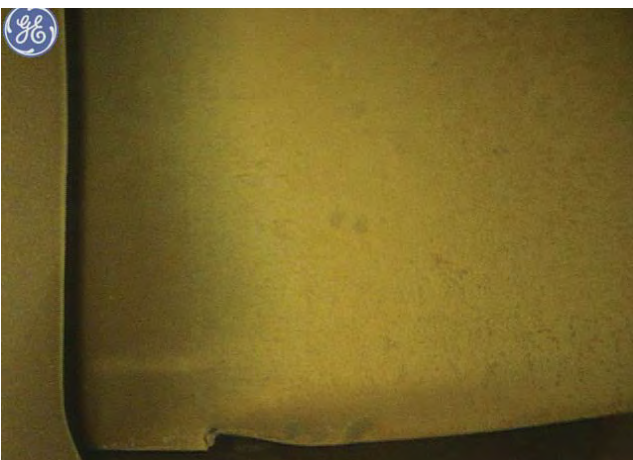
HPC STG12 Blade Nick on L/E Blade

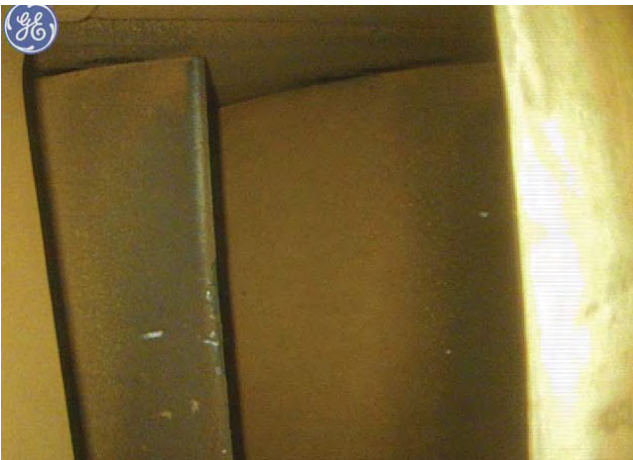
HPC STG15 Blade

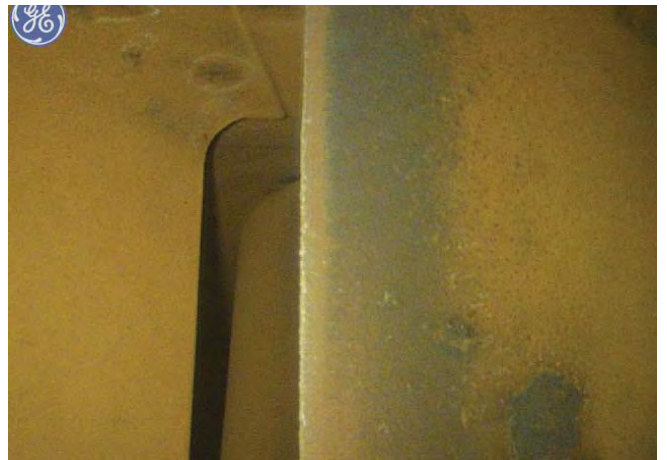
HPC STG15 Blade

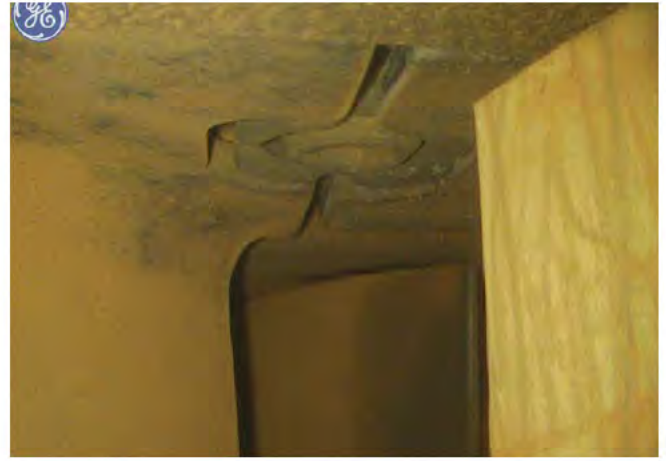
HPC STG16 Blade Locking Lug

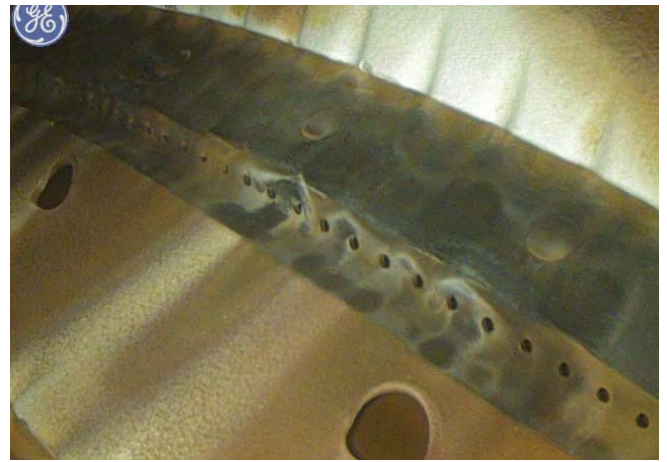
Inner Dome plate cooling holes and rivets are good conditions.

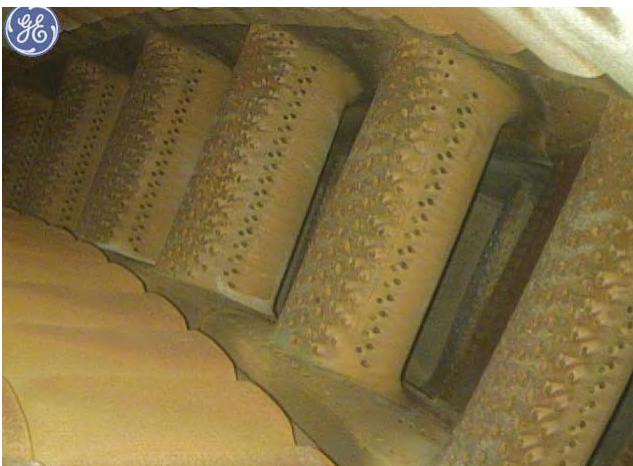
HPT STG1 Nozzle Vane Leading edge.

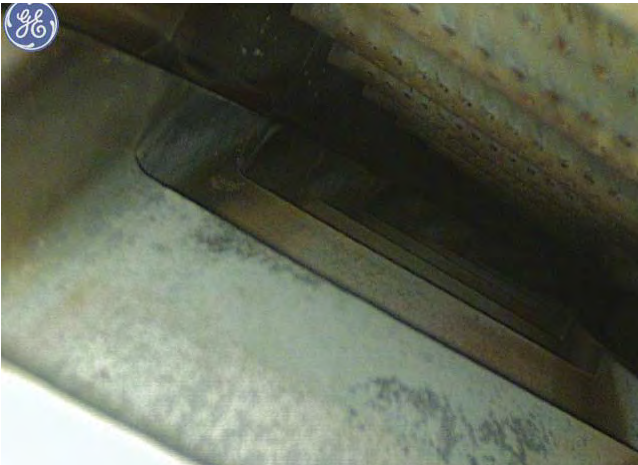
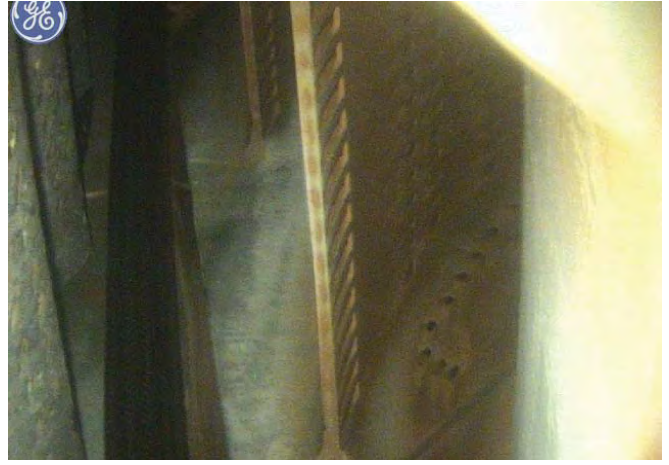
- Observed Eroded areas on the two HPT STG1 Nozzle Vane Trailing edge sides. Serviceable.
Ref: Table:7 /2f

HPT STG1 Nozzle Vane Trailing Edge

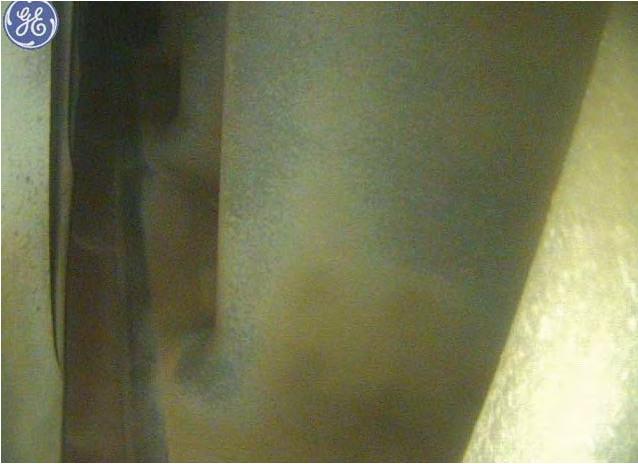
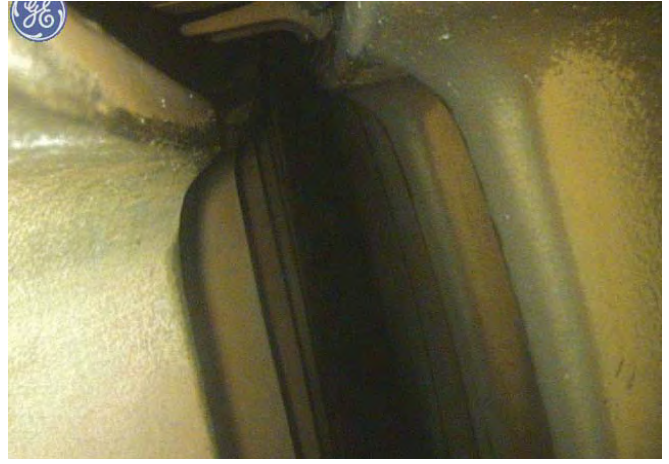
- Discoloration all surface on STG2 Nozzle.

HPT STG2 Nozzle LE sides.

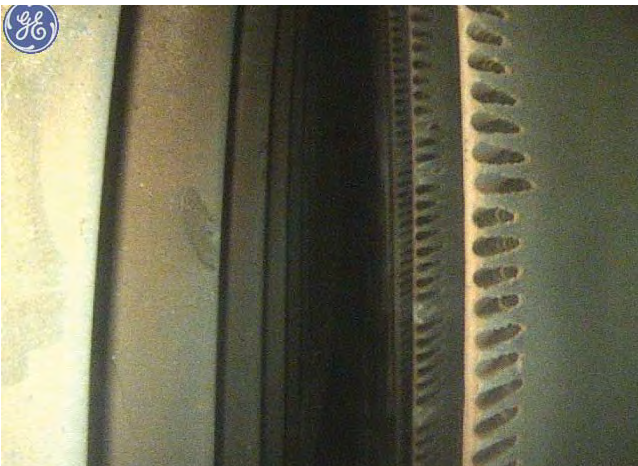
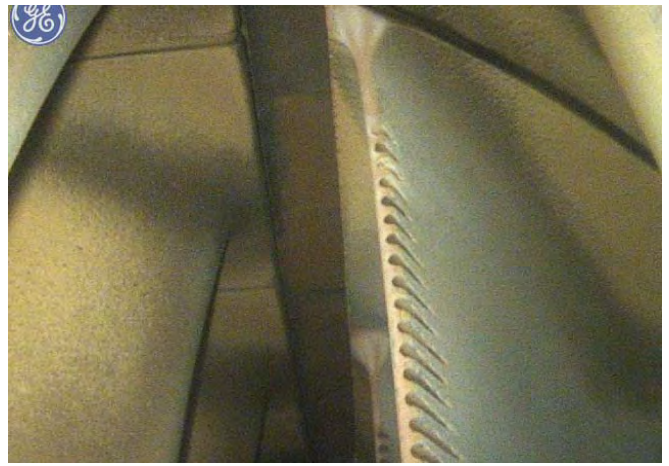
HPT STG2 Nozzle TE sides

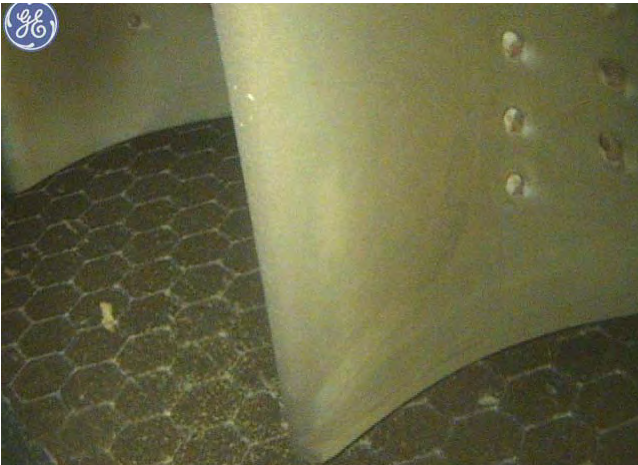
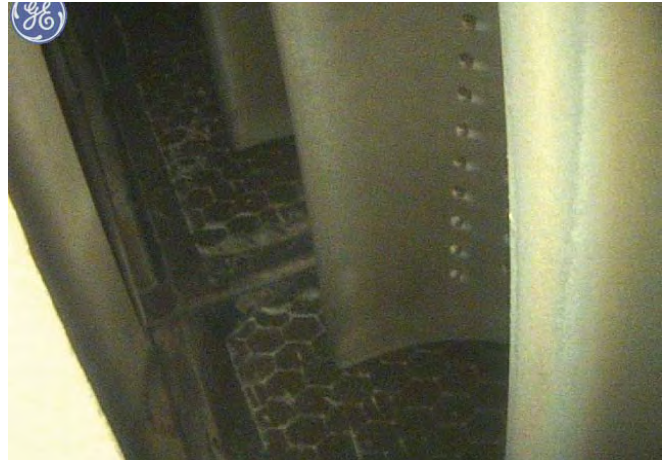
- HPT STG2 shrouds found intact free from any sign of damage.

HPT STG2 shroud.

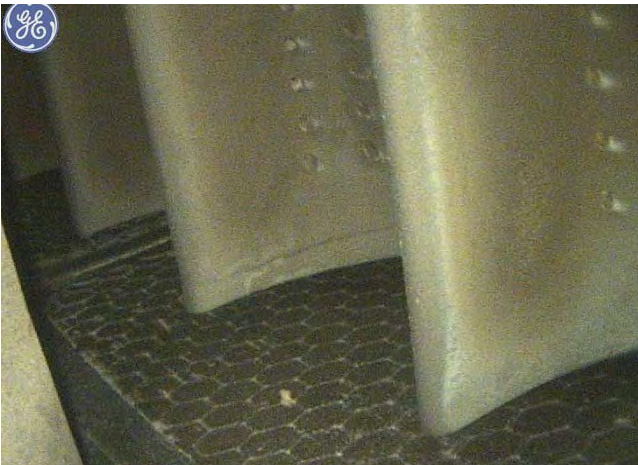
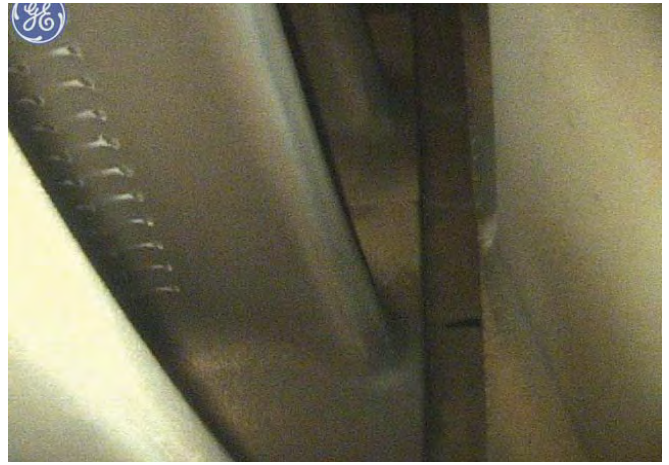
HPT STG2 Rotor Blades are in good condition. Observed some deposit on concave surface of blades.

HPT STG2 Rotor Blades LE View.

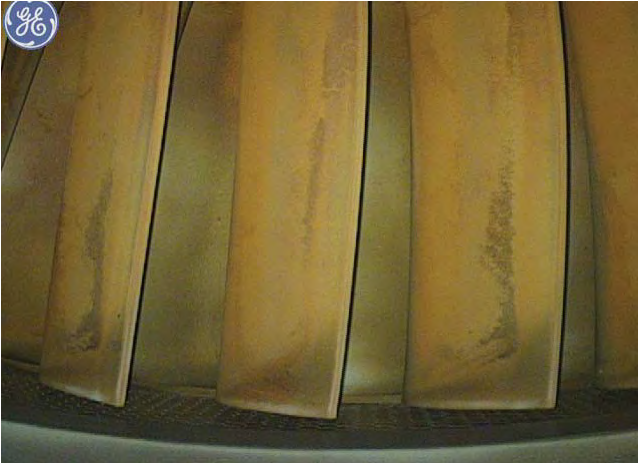
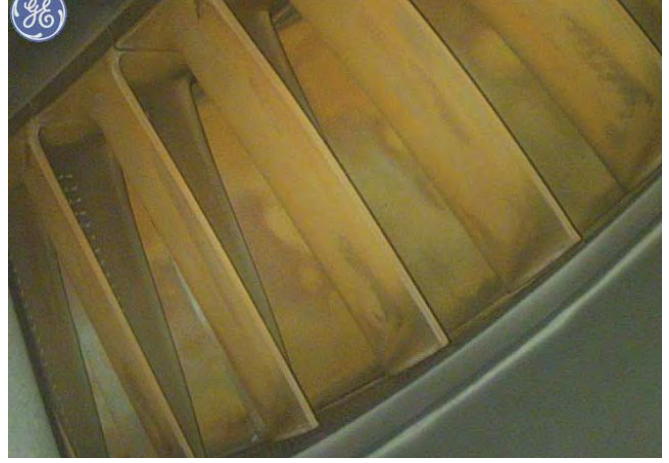
HPT STG2 Rotor Blades TE View

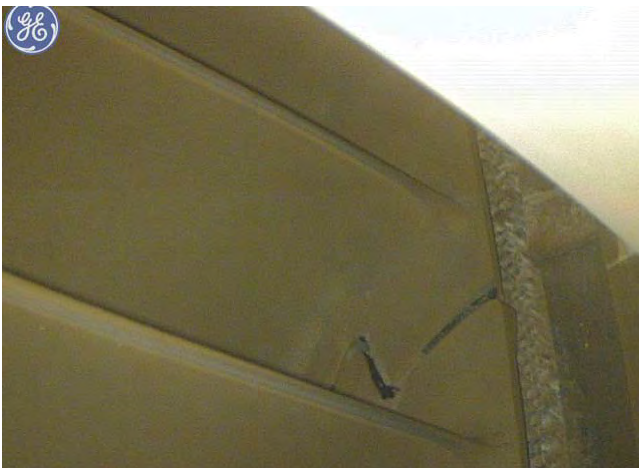
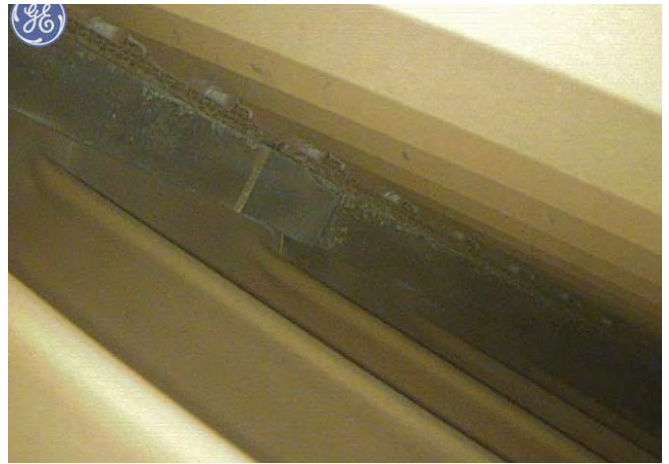
PT STG1 Rotor Blades

PT Rotor Blades are in satisfactory condition.
